Journal of Construction Materials

Evaluation of corrosion in steel reinforced concrete with brick waste

Abstract

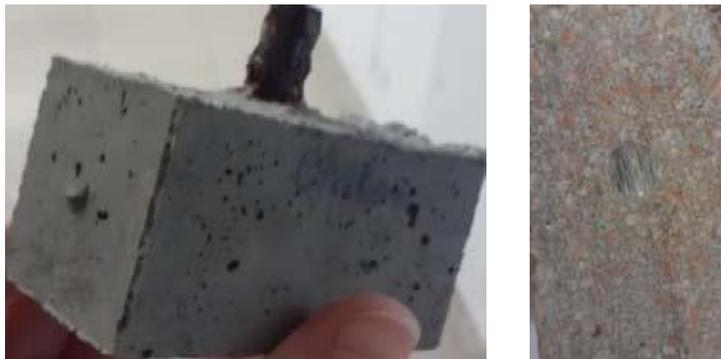
Figure 1 - The mortar samples. Left: General view, Right: Cross sectional view

The raw mortar samples were poured into metallic molds with 40 mm x 40 mm x 160 mm in size. The steel rebar with 6 mm diameter was embedded in middle of mortar samples (Figure 1). The samples molds with mortar were maintained in RH 95% during 24 hours. For the corrosion tests, the samples were removed from the mold and cured in humidity atmosphere.

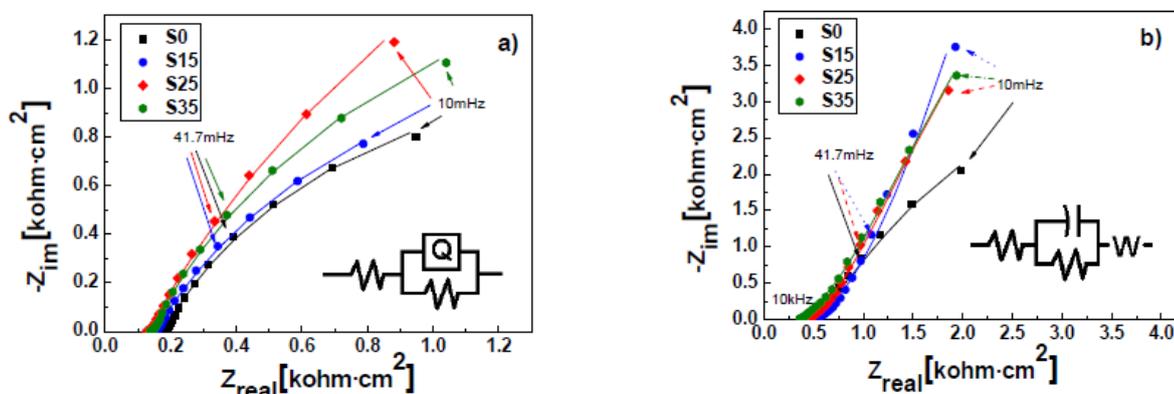
Figure 2 - Nyquist impedance diagrams for the rebar electrodes at: (a) 1 month, (b) 26 months, immersed in 3 wt.% NaCl; the lines represent fitted data

The EIS plots were recorded immediately after OCP in order to investigate the behavior corrosion of steel rebar in different compositions of mortar. The results are presented in Figure 2. The Nyquist plots for samples that were maintained for 1 month in humid conditions indicated that the impedance spectra exhibit one depressed capacitive loop (Figure 2 (a)). The impedance spectra were analyzed for all samples by fitting the experimental data with an equivalent electrical circuit that contain only one R-C couple (Figure 2 (a)); R_{ct} representing the charge transfer resistance and, C_{dl} the double layer capacity, at the rebar steel | electrolyte interface. The values of C_{dl} were calculated using equation (1):

Analyzing the Nyquist plots in the case of samples maintained for 26 months in humid conditions, it can be noticed a completely different behavior compared with samples maintained for 1 month. The impedance spectra were analyzed for all samples by fitting the experimental data with a R(CR)W equivalent electrical circuit. The presence of Warburg impedance indicates that the electrochemical reactions are controlled by diffusion phenomenon (Figure 2 (b)). The $R\Omega$ represents the electrolyte resistance between the reference electrode and the work electrodes surface, in the case of both equivalent electrical circuits used. To understand the electrochemical process occurring at the WEs surface, the parameters for all samples were obtained by using the proposed equivalent electrical circuits. The quality of fitting procedure was evaluated by the chi squared (χ^2) values, which were of the order 10^{-4} . The results are shown in Table 3.

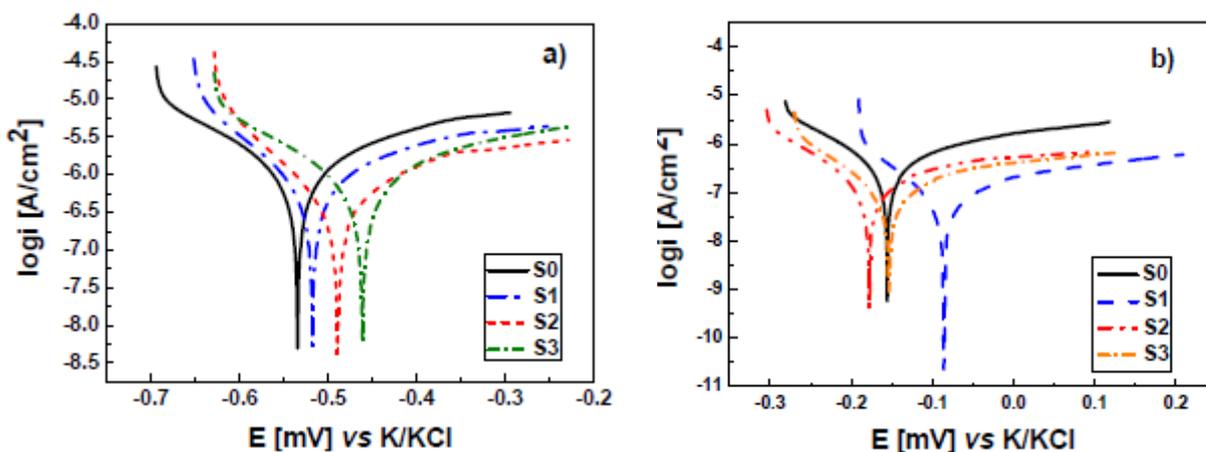
Figure 3 - Polarization curves (± 200 mV vs. OCP) recorded for rebar imbedded in mortar: (a) 1 month and (b) 26 months.

To determine the corrosion current density (i_{corr}) and the corrosion potential (E_{corr}), the potentiodynamic polarization curves were recorded in the potential range of ± 200 mV vs. OCP (Figure 3).

For all mortar samples, the results obtained by Tafel interpretation of the polarization curves are presented in Table 4. Based on these results, it can be observed that after maintaining the samples in

a humid atmosphere for 1 month, the values of i_{corr} are very close in all cases. This behavior assumes that the addition of BW has no influence on the corrosion properties for a short period of time. On the other hand, analyzing the results obtained after 26 months, it can be observed that the values of i_{corr} indicated a pronounced decrease for all samples that contained BW. The highest corrosion resistance ($R_p = 90.47 \text{ k}\Omega \cdot \text{cm}^2$) and the lowest corrosion current density ($i_{corr} = 0.08 \text{ }\mu\text{A}/\text{cm}^2$) were noticed at 15% concentration of BW. This agrees with the results obtained from the EIS measurements.

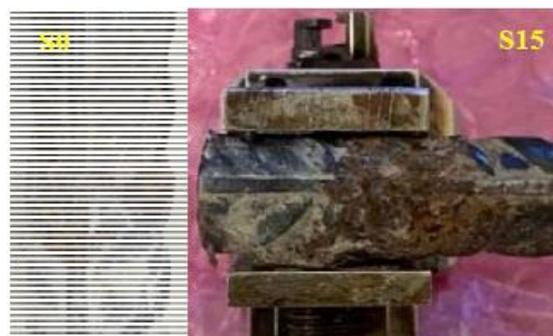
Figure 4 - Rebar samples for SEM-EDX analysis

SEM-EDX analysis was used for illustrating the intermediary layer between steel rebar and mortar matrix (S0 and S15). The steel rebar samples are presented in Figure 4. Visual examination on the surface of the rebar embedded in mortar does not show corroded areas. However, the area directly exposed to the external conditions presents a severe corrosion. The results of the SEM-EDX analysis are presented in Figures 5 and 6.

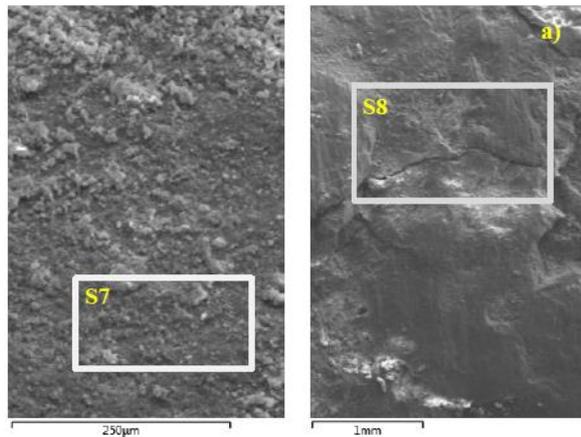
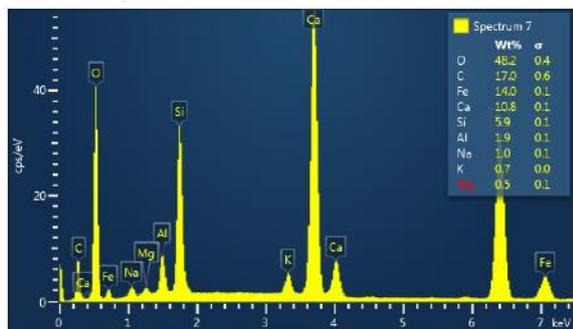
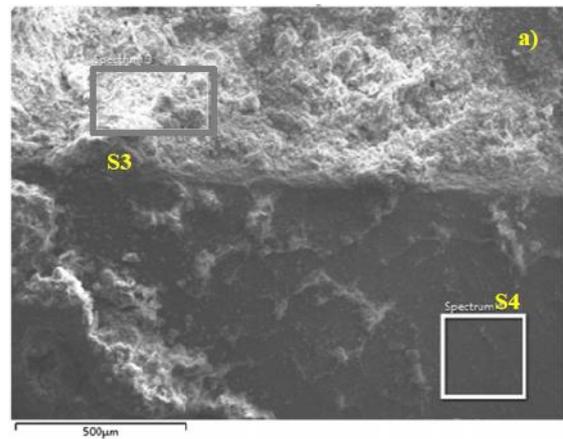
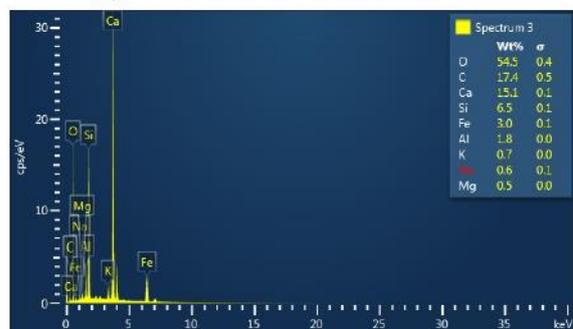
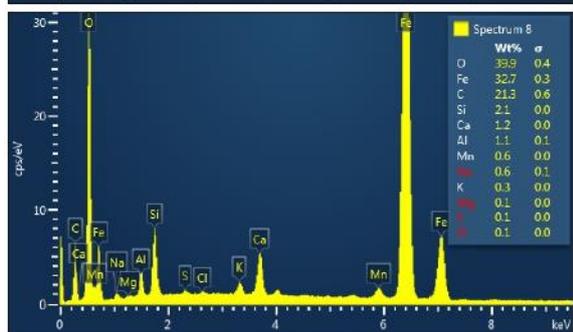
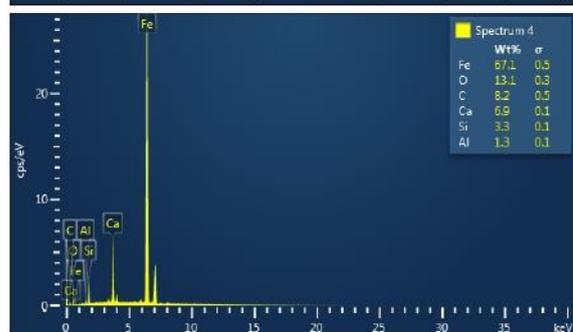
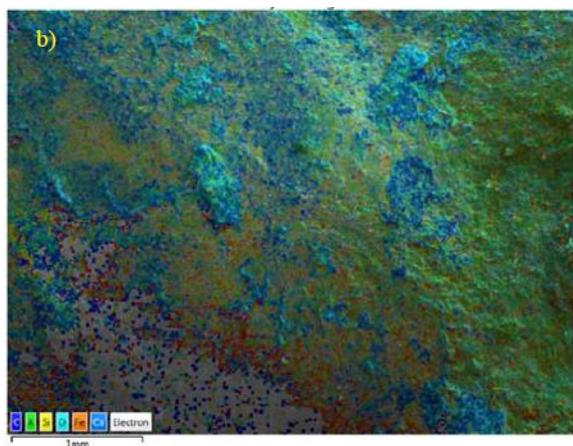
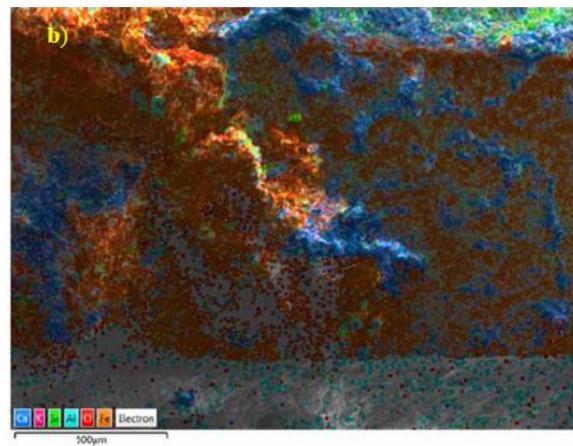
Figure 5 - SEM-EDX analysis for the S0 sample

Figure 6 - SEM-EDX analysis of the S15 sample

By analyzing the distribution of elements (Figure 5 (b)) the intermediate layer between steel and concrete can be observed. Also, on the steel surface, predominate Fe and C with small amounts of Ca are observed. The presence of the Ca, in the form of hydroxide, increases the pH of the system and provides protection against corrosion to the reinforcement.

In case of the rebar embedded in concrete with 15% WB, based on the SEM-EDX the presence of a high quantity of Ca compared with the etalon concrete can be observed (0% WB). Also, the presence of alkalis which dissolve easily, maintained the pH at high values, which gives the system a good anticorrosive property. The results obtained by SEM-EDX analysis are consistent with the corrosion tests.
